MAXIV Status and Development

Dr Stephen Molloy
Head of Accelerator Operations

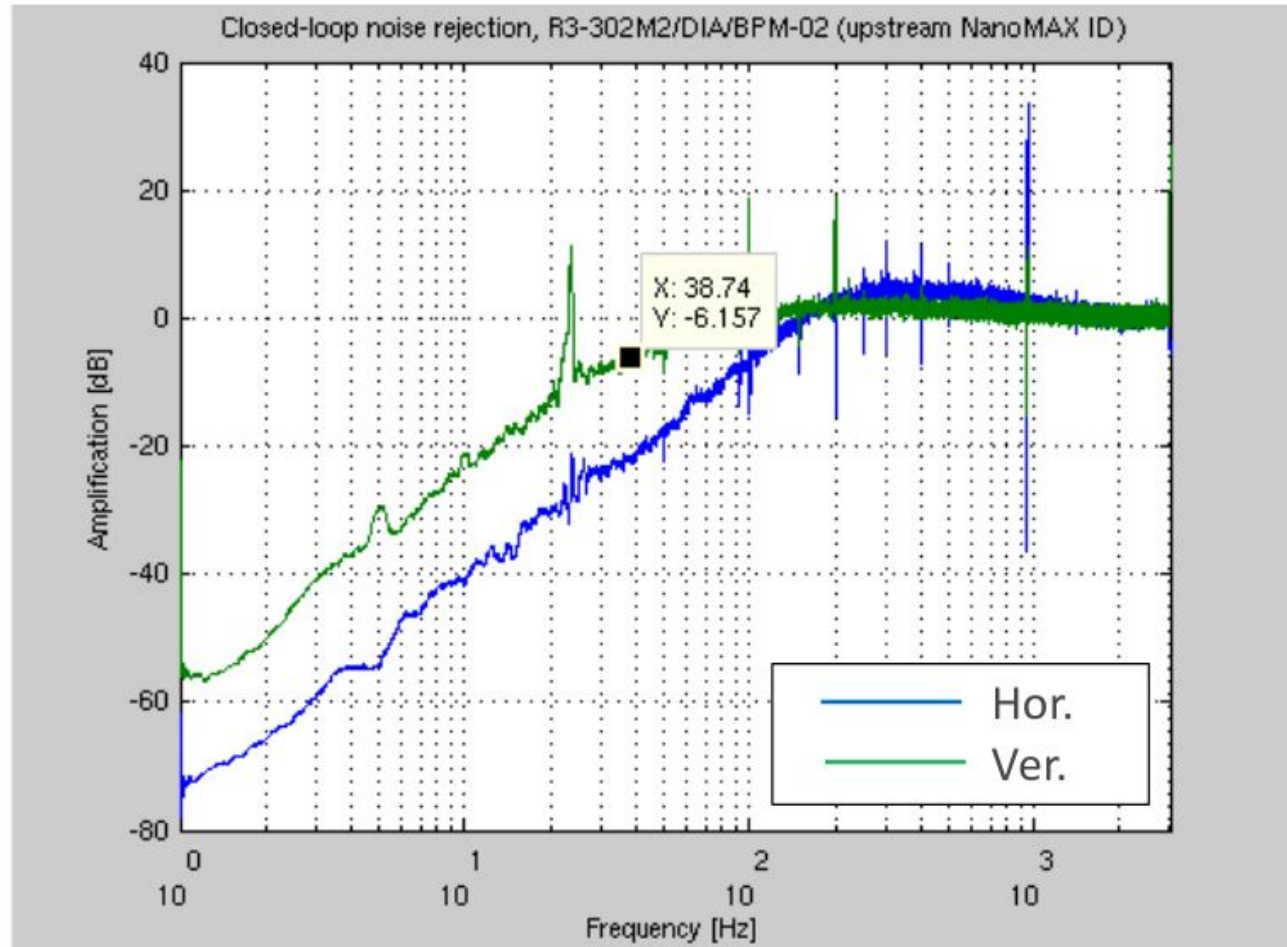
Noise rejection w. global FOFB

Current closed loop performance as seen on a BPM flanking the NanoMAX ID straight. It should be noted that the FOFB configuration is currently limited by FPGA bit-cutting, resulting in a closed loop BW of 100 Hz in the horizontal plane and ~40 Hz in the vertical. Plots based on 20 minutes of data collected at delivery conditions.

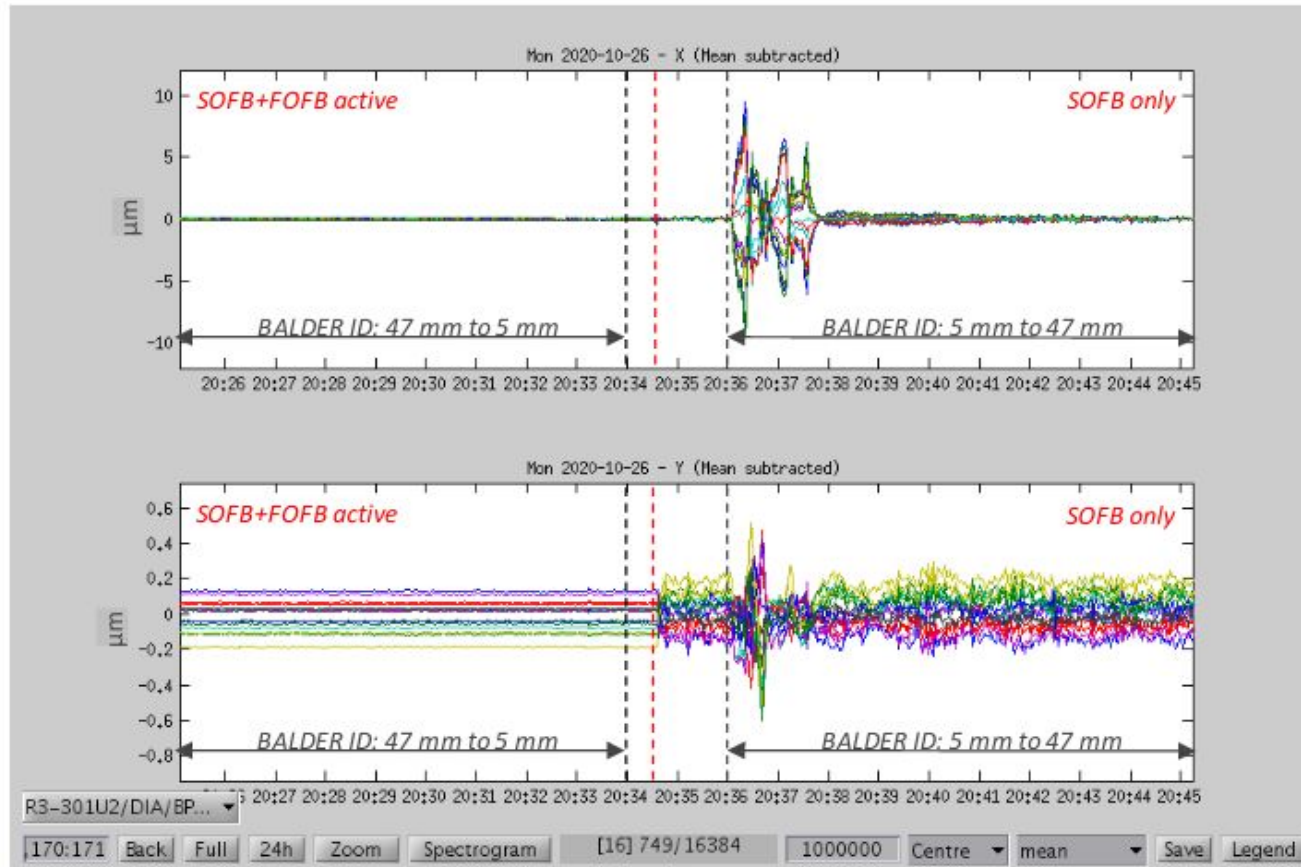
ID-induced transients

Looking at all BPMs flanking user IDs the combined SOFB+FOFB is able (even at more conservative settings with 30 Hz BW in both planes) to largely eliminate the orbit transients.

BALDER ID is an in-vacuum wiggler and has a very noticeable orbit impact at low gaps.

Of note is that no fast correctors ($\pm 10 \mu\text{rad}$) ever exceed 10% of the strength.

NB! Plot displays highly averaged 10 kHz data (16384 samples per point).

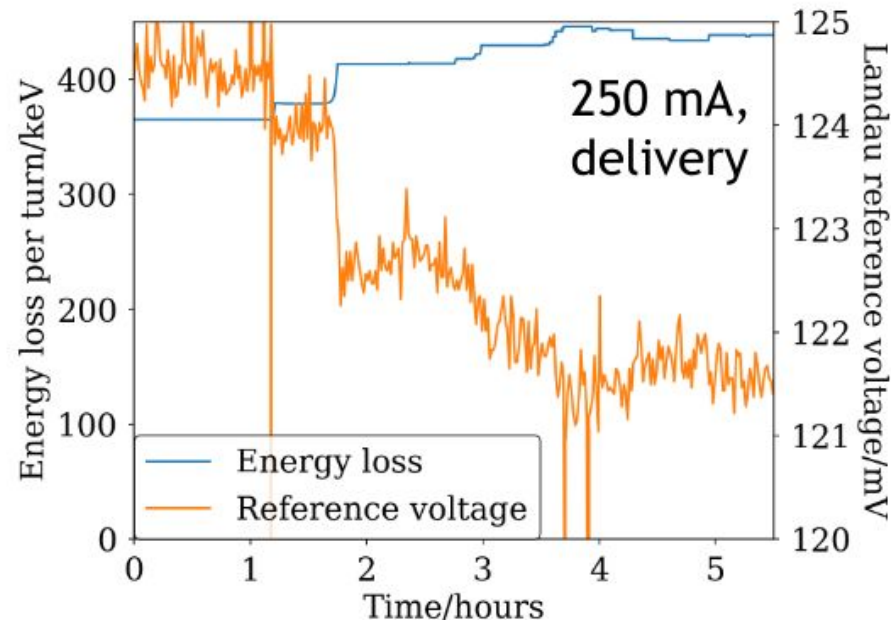
Feed-forward device for flat potential

- Newly commissioned Tango device
- Maintain flat potential as IDs are closed (assuming evenly-spaced bunches with given form factor)
 - RF voltage with zero first derivative - Landau fields only
 - Zero first and second derivative - main and Landau fields
- Additional flexibility (current level, parked cavity, etc.)

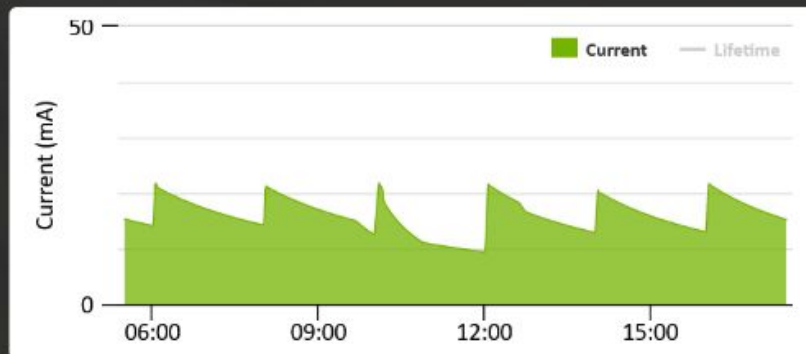
1.5 GeV ring, Single Bunch Delivery

- Thermionic gun used for single-bunch injections:
 - TG delay decreased to clip end of bunch train
 - DC chopper delay increased to clip beginning of bunch train
- Scraper inserted and parasitic bunches excited using bunch-by-bunch system to clean them out
- Process now automated, injection every two hours

FlexPES	38.52
SPECIES	34.15
BLOCH	38.19
MAXPEEM	29.87
FinEst	44.40

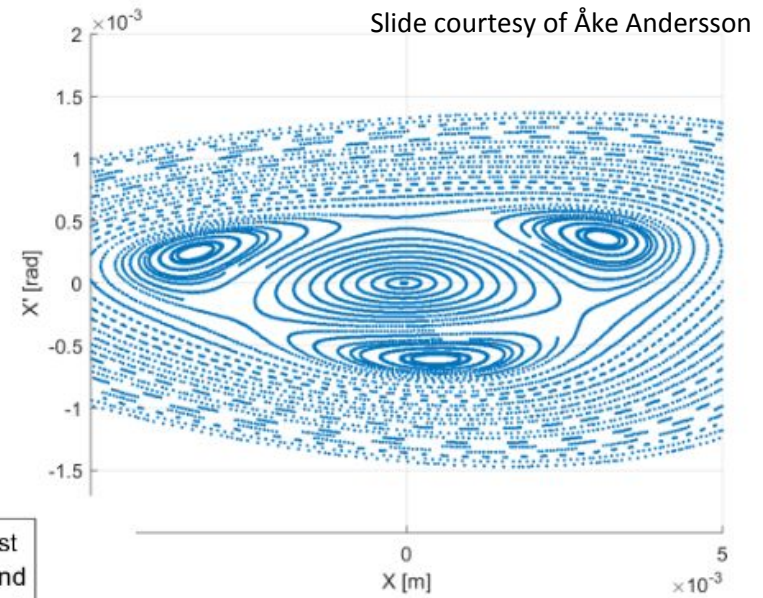
TRIBs Optics Characterisation

The LOCO fit corresponds well with what we see at the diagnostic beam lines.

Tracked island and core buckets at centre of first straight section (approximate position of BBB kicker).

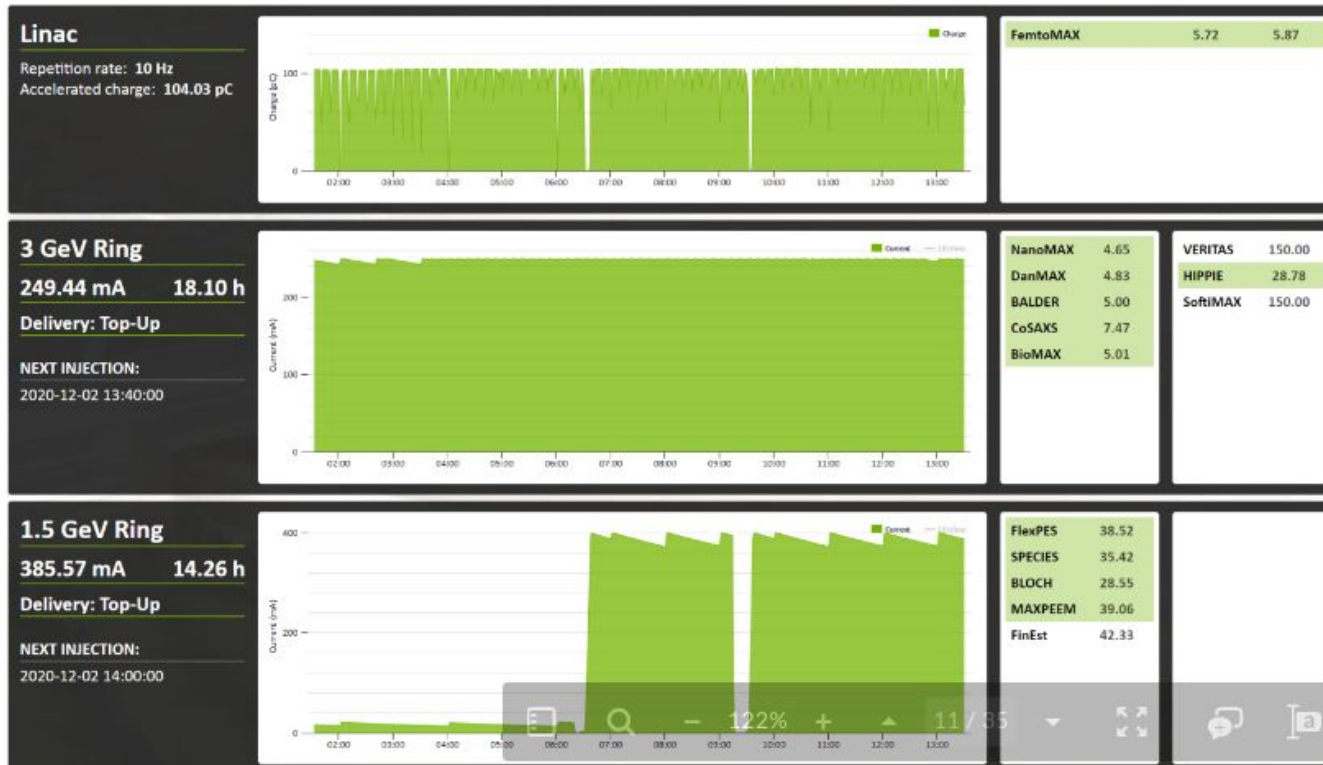
10 Hz operation

- Radiological commissioning week 47-week 48
 - Issues with chopper aperture heating was resolved
 - Dual repetition rate operation
- SPF, 100 pC, 10 Hz, from week 49 and onwards
- R1, up to 500 mA/min
- R3, up to 100 mA/min
